JRC TECHNICAL REPORT

M7.8 and M7.5 Earthquakes in Türkiye and Syria

Update of the EC-JRC Scientific Analysis – Report #6 as of 27 February 2023 at 14:00 UTC

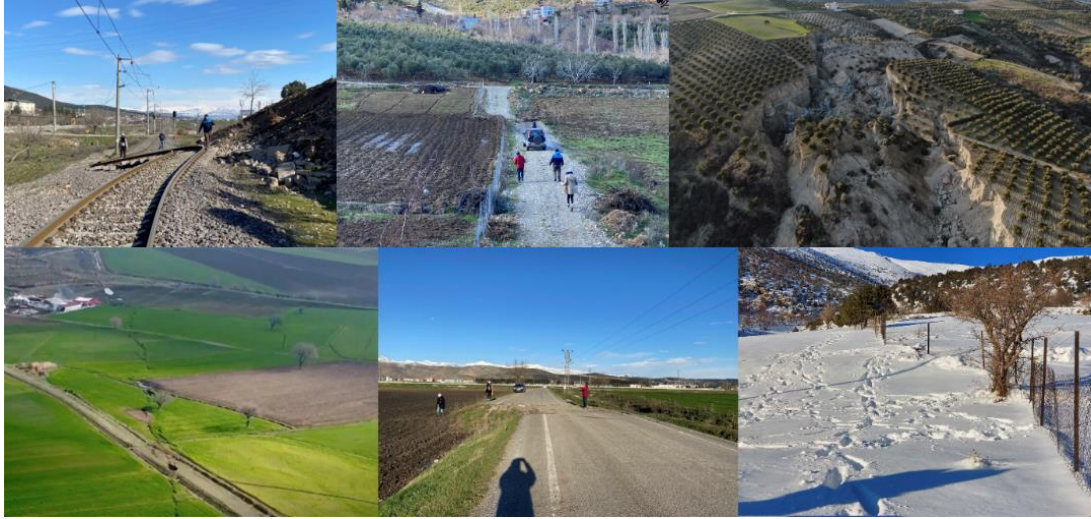
Figure 3. Surface ruptures in Türkiye generated from the 1st earthquake with M7.8 and 2nd earthquake with M7.5. (top-left) Kahramanmaraş-Şekeroba (top-left ⁴ and top-centre ⁵), Hatay (top-right ⁶), Kahramanmaraş-Tevekkeli (bottom-left ⁷), Kahramanmaraş-Türkoğlu (bottom-centre ⁸) and along Sürgü-Çardak fault (second earthquake) (bottom-right ⁹).

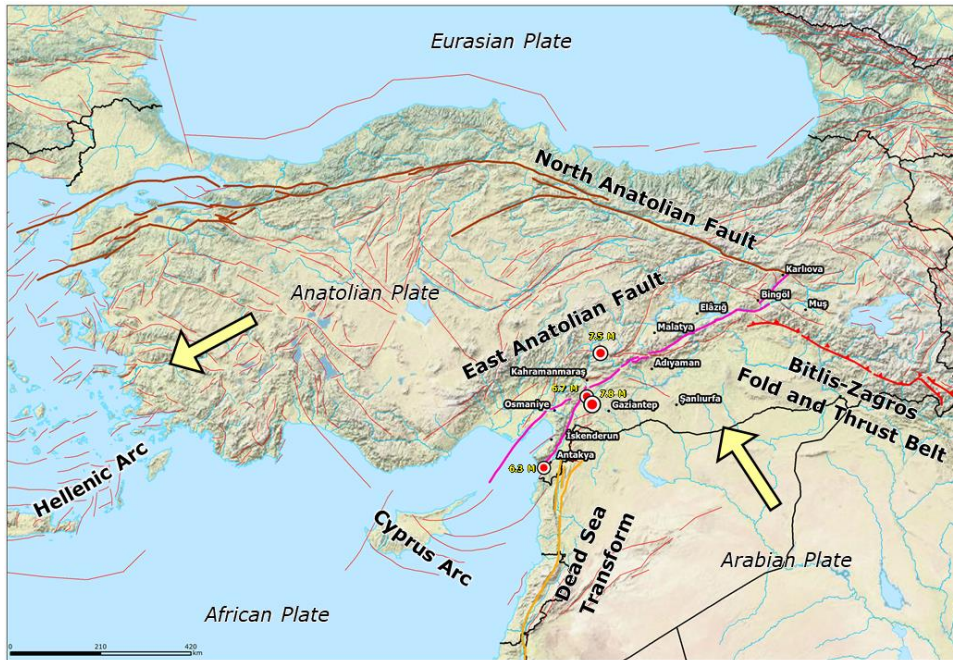
Figure 5. Main tectonic structures of Anatolia and Middle East. North Anatolian Fault (NAF), East Anatolian Fault (EAF), Dead Sea Transform (DST), Bitlis-Zagros Fold and Thrust Belt (BZFTB), together with the two main earthquakes, two major aftershocks and the administrative regions along the DAF and EAF in Türkiye.

The earthquakes in Türkiye on 06 February 2023 occurred on the East Anatolian Fault (EAF), which is a major transform type tectonic boundary between the Anatolian Plate and the northward-moving Arabian Plate accommodated mainly by strike-slip faults, starting from the Maras Triple Junction (MTJ) at the northern end of the Dead Sea Transform (DST) and ending at the Karliova Triple Junction (KTJ) where it meets the North Anatolian Fault (NAF) (Figure below). Aftershocks of the first

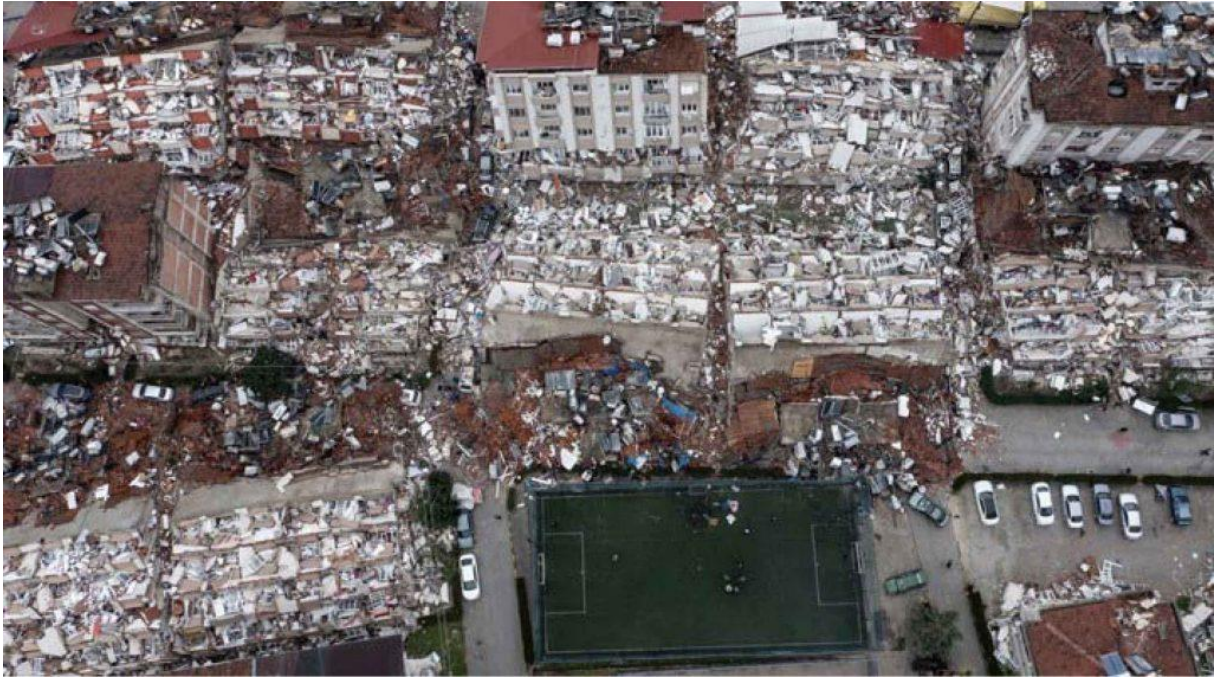
Figure 15: Pancake collapsed buildings in Hatay (Credit: IMO²⁶)

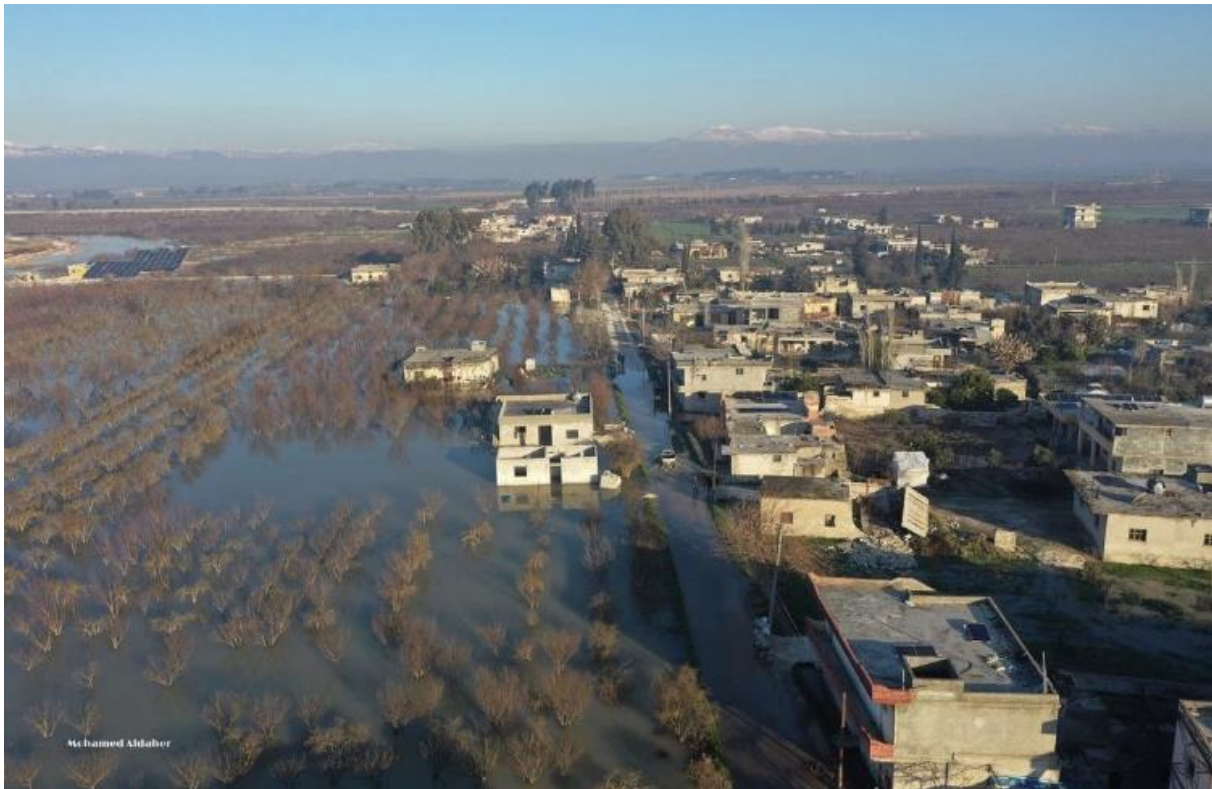
Figure 16. Image of the flooded area in the along Al-Taloul village, along the Orontes/Asi River, in Syria.

The flooding was detected by different sources (JRC GloFAS GFM, UN OCHA, UNOSAT, NASA-MODIS) over the period from 7 to 24 February and occurred on both side of the border area between the Hatay Province (southern Türkiye) and Idlib Governorate (north-west Syria). In this latter, due to the presence of more settlements along the river valley, the floods led to population displacements (around 30 000 people) from several villages, in particular: Al-Talul, Dergoush, Al-Jameiyah, Hardana, Delbiya, Jakara, and Hamziyeh. The flooding affected approximately 1 000 houses across the aforementioned villages.

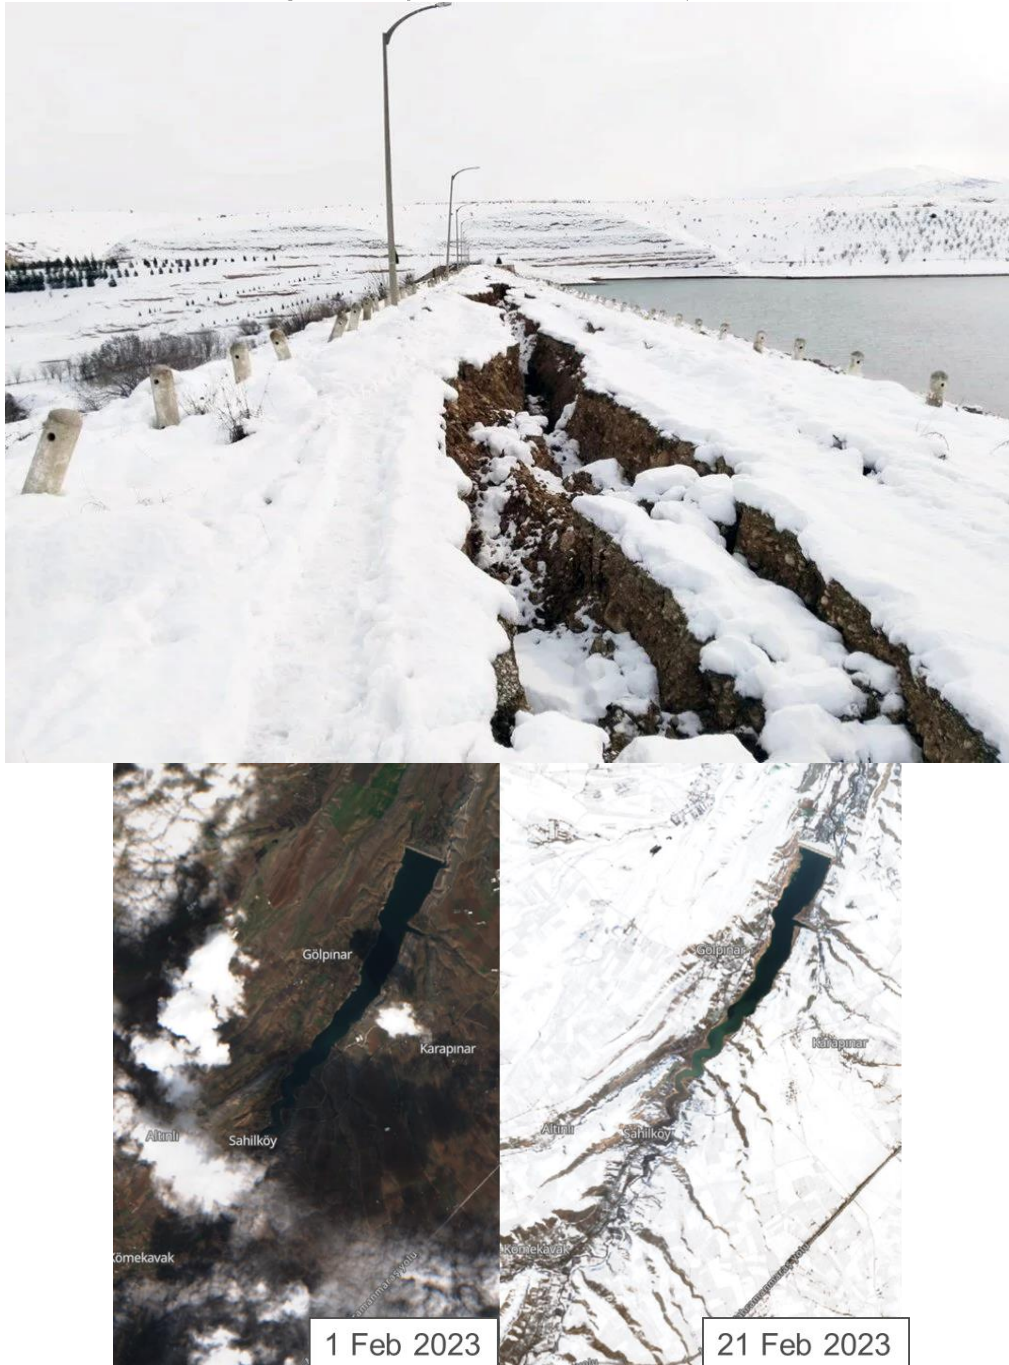
Figure 20. Longitudinal cracks on the Sultansuyu Dam.

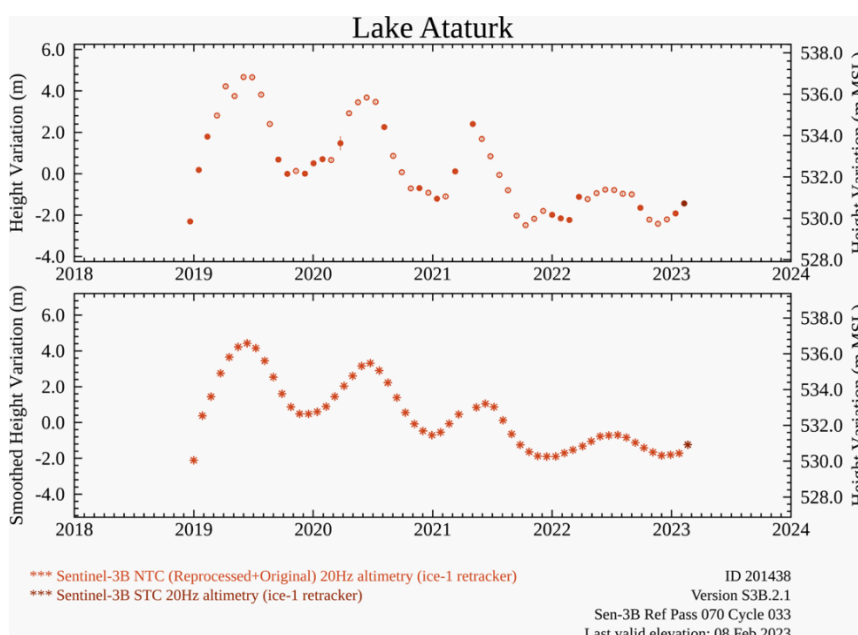
Figure 21. Altimetry data to monitor the level of the *Atatürk Dam* (source: G-REALM).

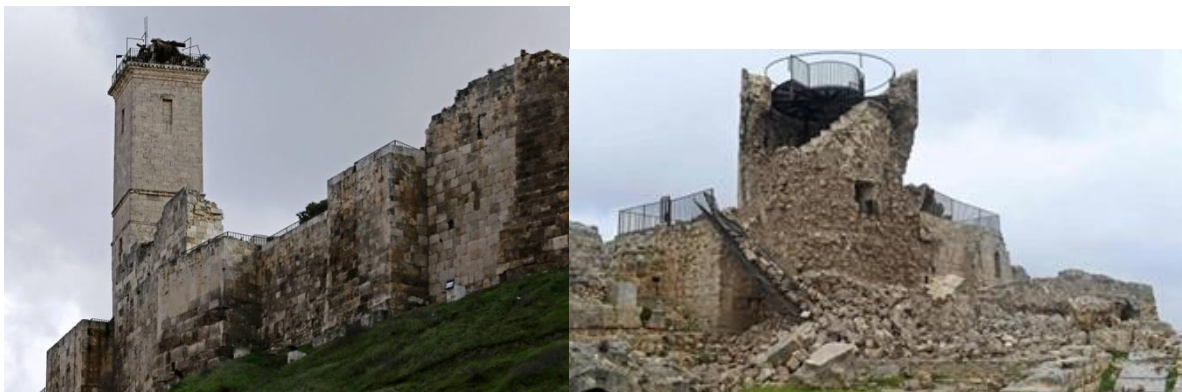
Figure 23. Images of earthquake impact on the Great Mosque of Aleppo in the Old Citadel Aleppo Old Citadel (left) and Al-Marqab castle (right) in Syria.

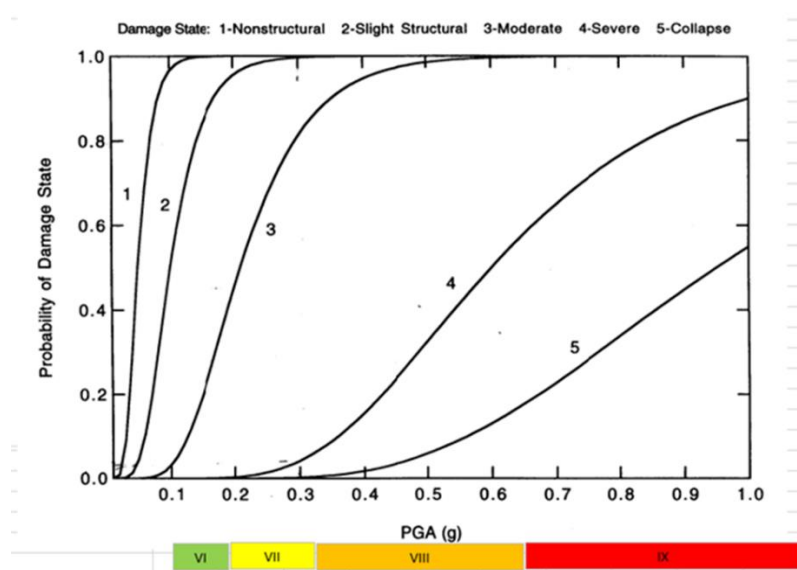
Fig. 1. Mean Damage Ratio vs Modified Mercalli Intensity Scale

As a conservative hypothesis, with the aim of assessing the worst-case scenario, the curve with the highest MDR values has been used, meaning that unreinforced masonry structures are assumed to be the representative type of structure in the area:

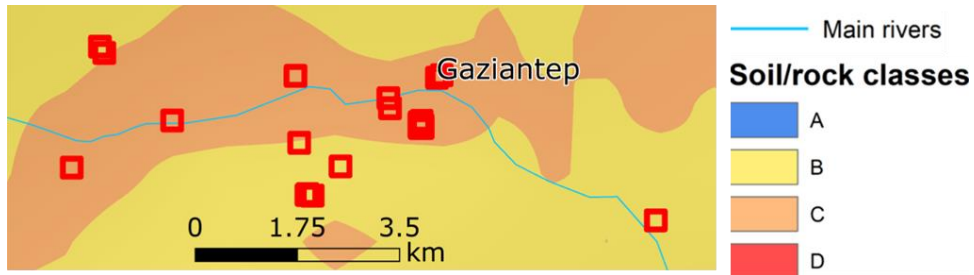
Figure 4. Damaged building – red squares (Copernicus) and the seismic amplification map.
