Lao People's Democratic Republic Flash Flood due to Dam Collapsing

Glide Number: FF-2018-000118-LAO
23 July - ongoing

UPDATE # 1 - Results of Dam Break Calculations

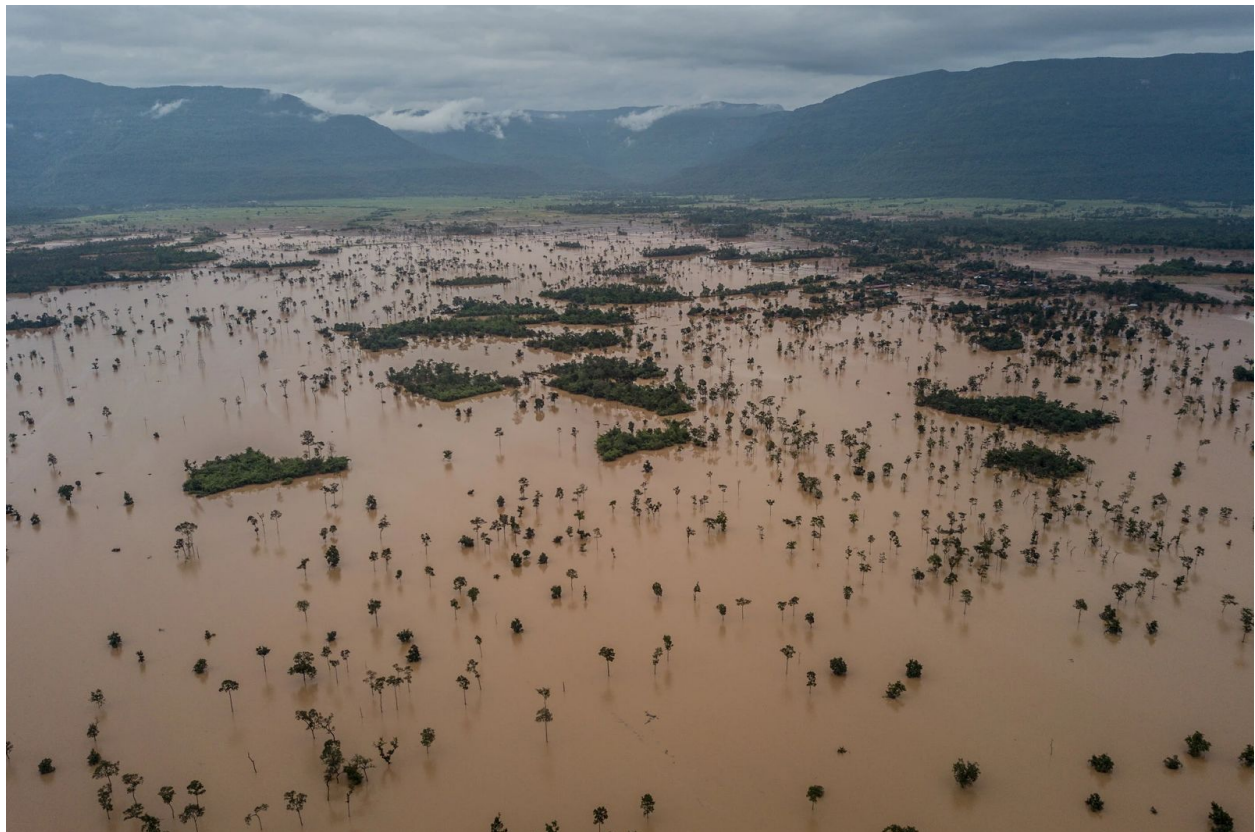
Fig 7- Floods due to the dam break (Source: <https://www.nytimes.com/2018/07/26/world/asia/laos-dam-collapse.html>)

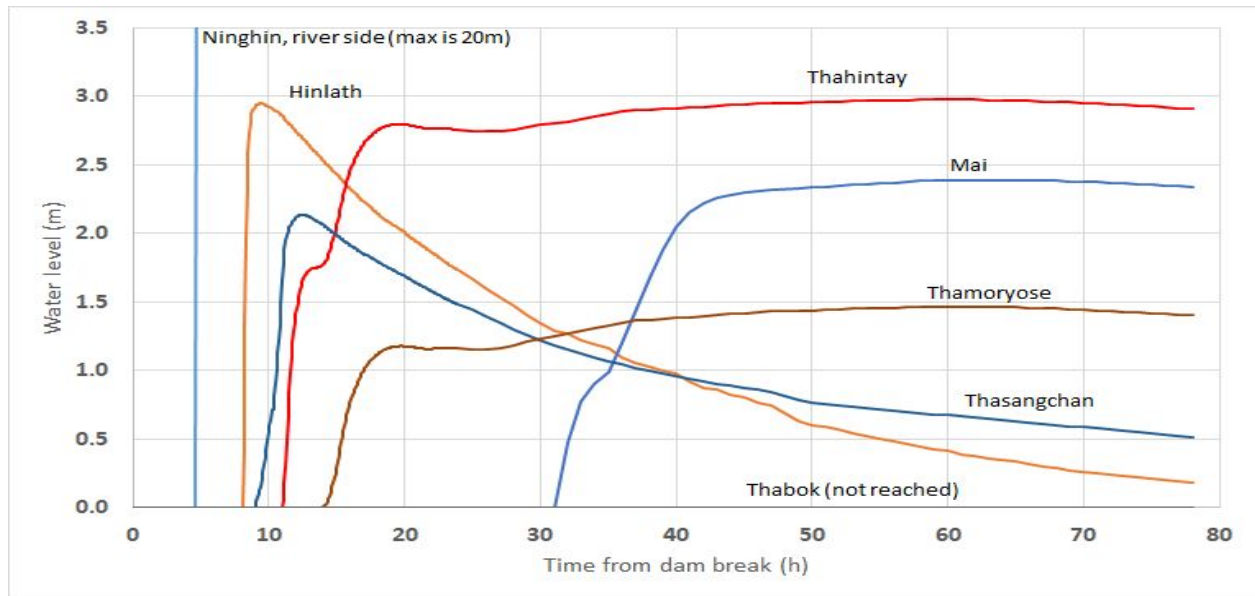
The behaviour of the level at the locations indicated above can be seen from the image here. After 24 h the water is still present in all the locations.

The timeline shows that the rise of the level, excluding the northern location, shows an almost stable level for long time. At the end of the calculation (80h), the level decrease at a rate of 0.1-0.2 m per day, which means, excluding further rains and evaporation, that between 10 and 20 days are necessary to void the various locations. Hinlath should be soon voided; the last one should be Thahintay.

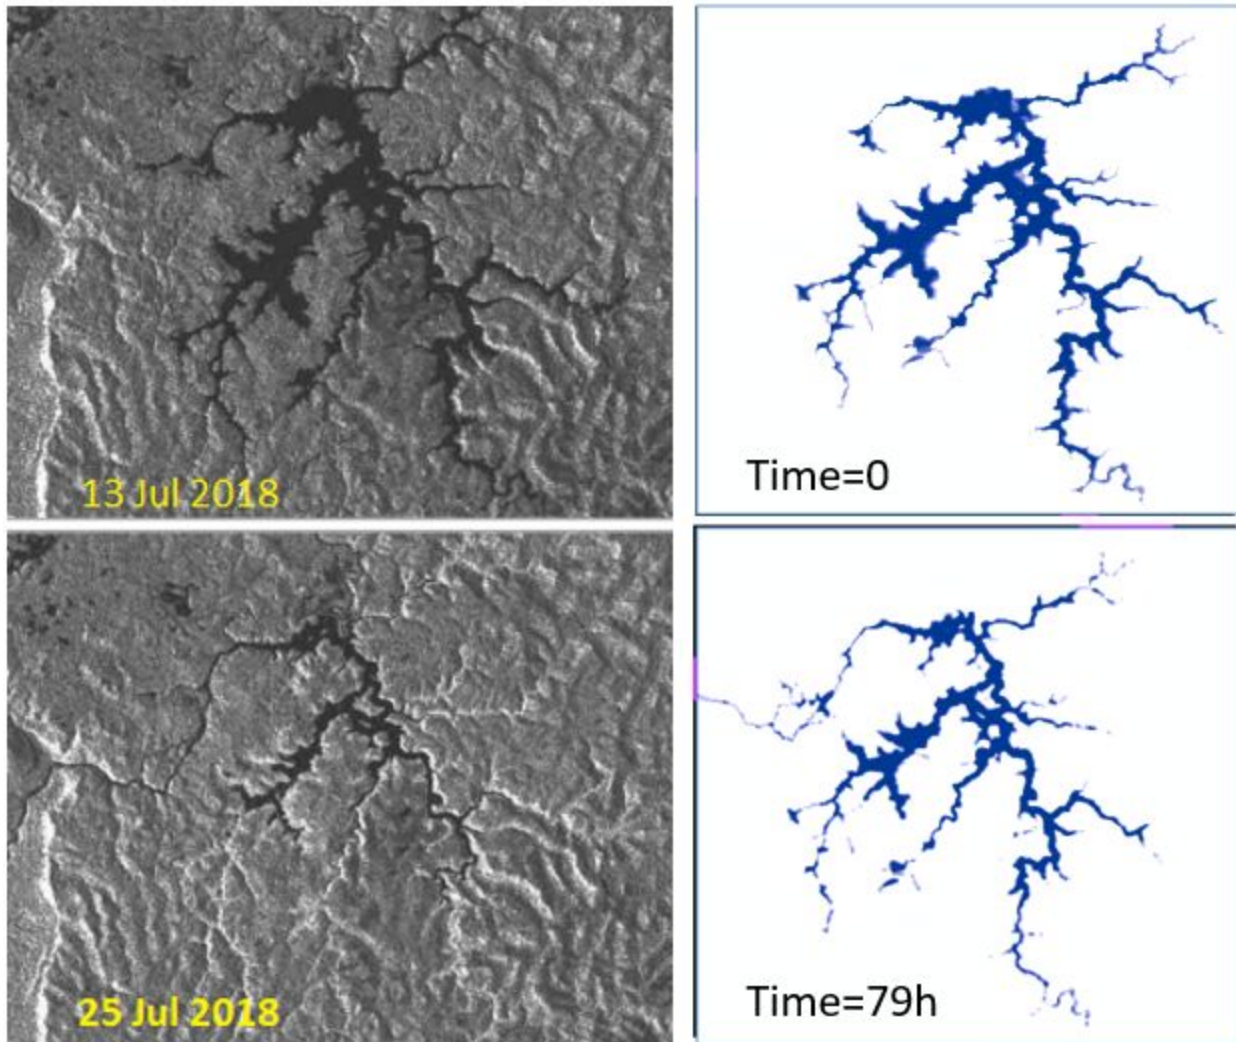
The voiding of the lake can be seen in the image above as obtained by satellite images (before and after the break³) and as calculated in the dam break analysis. In both cases it is evident the strong reduction of the surface of the lake.

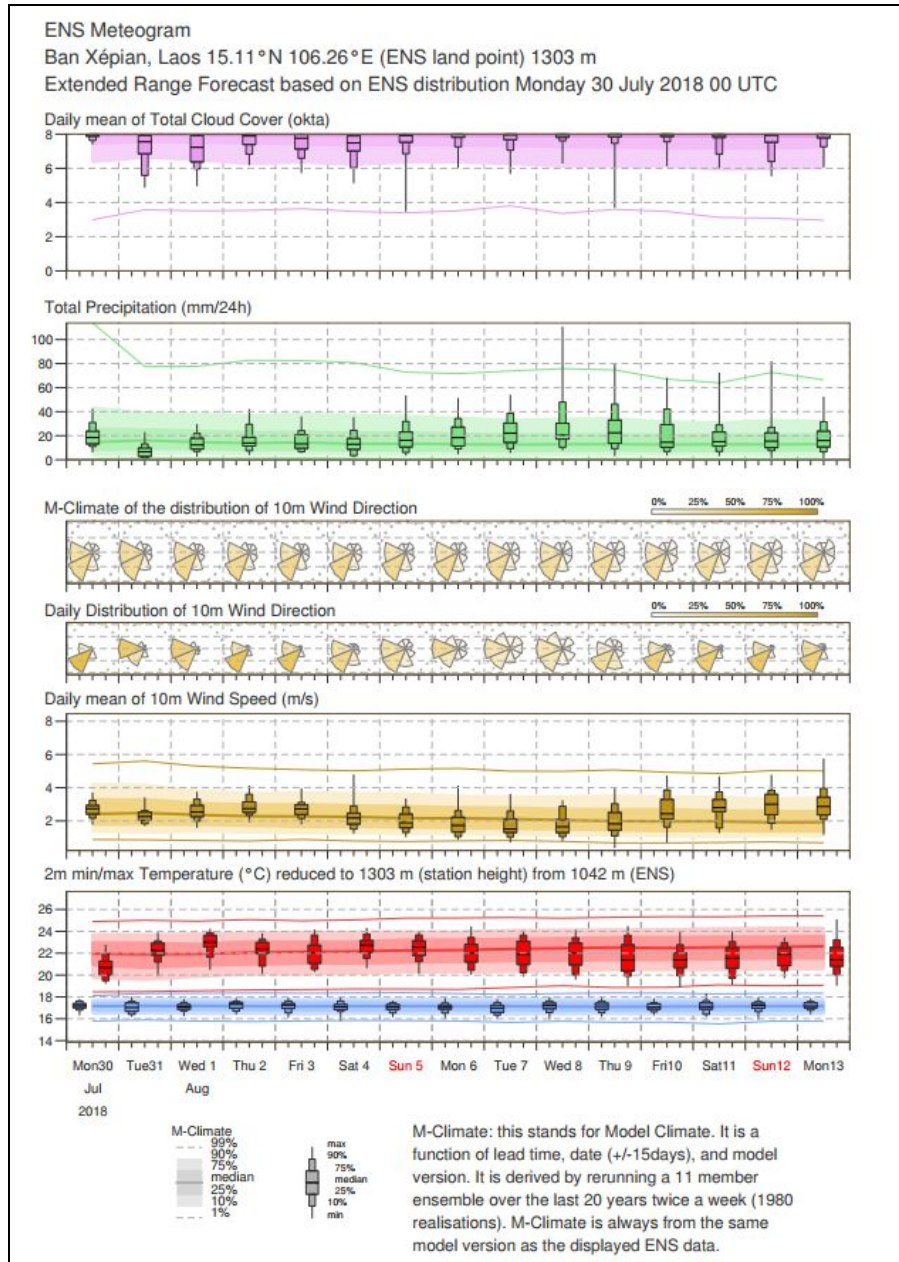
A pinpoint Meteogram over the next 15 days for the reference closest grid point (3 km to the south-west) to Xepian-Xe based on the Ensemble Prediction System (EPS) of ECMWF has been compiled comprising main weather elements. M-Climate (model climate) values are also included for reference. Based on the Meteogram of Figure A2.1, cloudy to overcast conditions are forecast for Xepian-Xe with local intense rains and thunder showers.

Figure A2.1 - 2-Week (15-Day) Meteogram for Xepian-Xe area based on 30 July 00 UTC EPS (Ensemble Prediction System) of ECMWF. The M-Climate (model climate) is also included.
