# Central and eastern Europe and Italy | Severe weather and floods

## Impact overview as of 20 Sep at 12:00 UTC

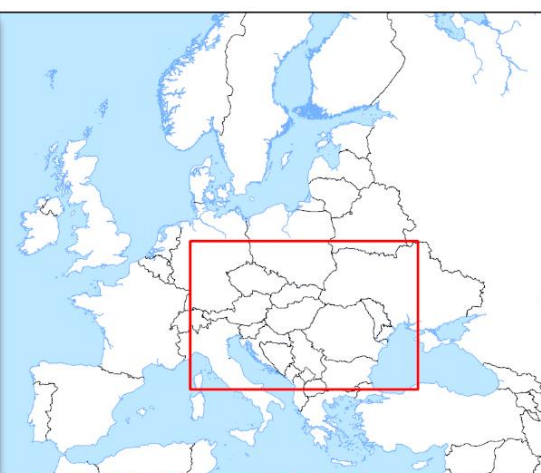
## Precipitation accumulation (mm) over 11 Sep to 18 Sep

Source: Copernicus EMS
